Civilian Conservation Corps Garbage Receptacles

Cultural Resource Brief

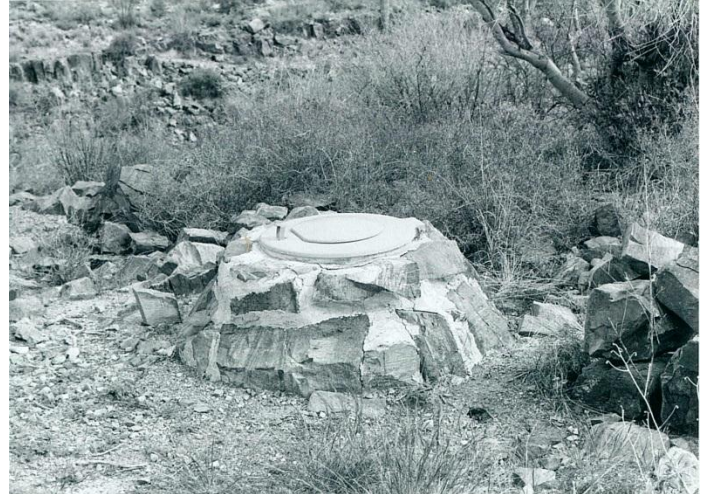
The intact garbage receptacle at Mam-A-Gah. Photograph taken in 1982.

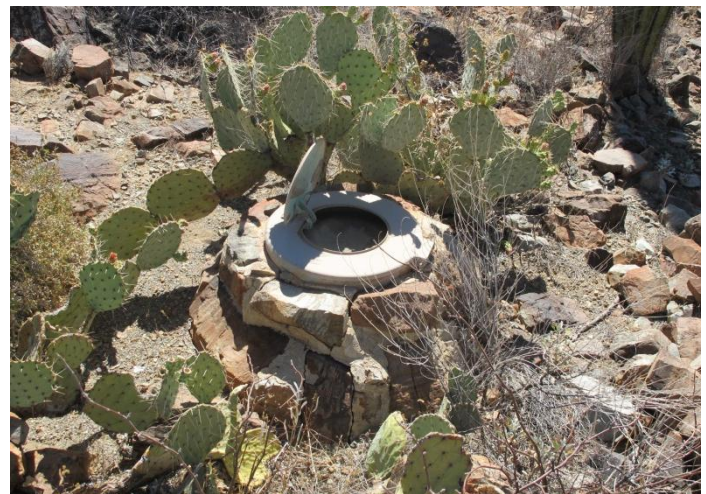
The only intact CCC garbage receptacle is at the Mam-A-Gah picnic area at TMD. It still retains a garbage pail which has been turned upside down within the receptacle. It is associated with Table 1 and Fireplace 1 located at the end of the ridge. It is constructed of stone with concrete mortar and has a metal liner that is connected to the retractable cover (see photographs at right). The cover has a built-in smaller foot-activated cover for visitor use. The maximum exterior diameter of the rockwork is roughly 3ft.; the interior is 18.5" in diameter and is 24.5" deep.

The intact garbage receptacle at Mam-A-Gah with foot-activated cover in the up position. This garbage receptacle is associated with a picnic table and fireplace located at the end of the ridge. Photograph taken in 2013.

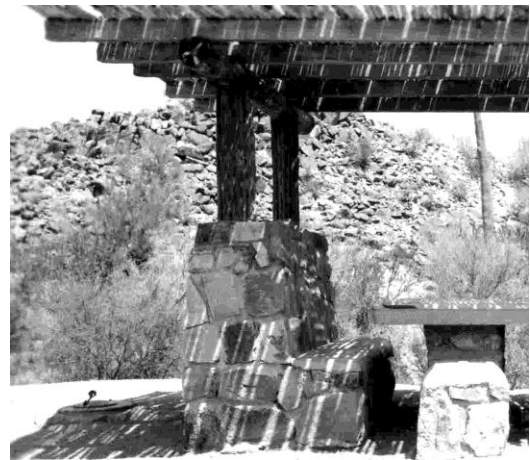
A photograph taken in the 1930s showing the small ramada at Signal Hill. Note the garbage receptacle with foot-activated cover lever at the lower left. This receptacle no longer exists. Signal Hill is in the background.

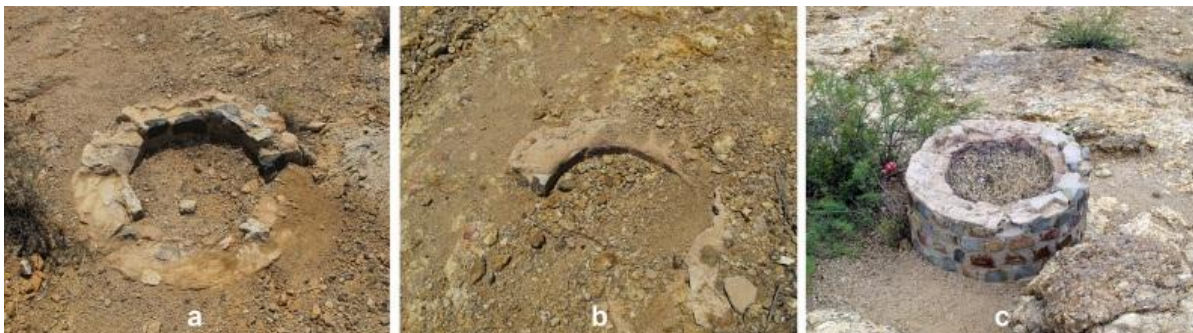
Hill (see photograph on page two) next to the small ramada. A third photograph shows a partially completed garbage receptacle behind the ramada at Gates Pass. Both garbage receptacles at Gate Pass stand much higher than the ones documented at TMD. No doubt this is because of the bedrock that covers much of the surface of Gates Pass renders excavation difficult.

The foundations of three garbage receptacles. The intact garbage receptacle at Mam-A-Gah and these three foundations are all that remain of the 14 garbage receptacles constructed by the CCC at TMD/TMP. a: Sus; b: lower of the two garbage receptacles at Gates Pass; c: the upper garbage receptacle at Gates Pass which is associated with the Shelter House.
